# Fatigue fracture of femoral stem in total hip arthroplasty after use of ultrasound: A case report

**Introduction:** Fracture of the femoral stem is an infrequent event in the follow-up to a total hip arthroplasty (THA). The authors describe the case of a patient exposed to continuous application of ultrasound therapy that led to detachment of the stem-cement interface, followed by fatigue fracture of the femoral stem and the need for revision surgery. The aim of this report is to point out the possibility of undesirable effects in the use of therapeutic ultrasound in areas with underlying orthopedic implants. **Case Report:** A 66-year-old male patient with a previous diagnosis of psoriatic arthritis, underwent bilateral total hip arthroplasty five years ago due to avascular necrosis of femoral head after use of corticosteroids. After the appearance of an intermittent aching pain over the lateral aspect of the hip (greater trochanter) trochanteric

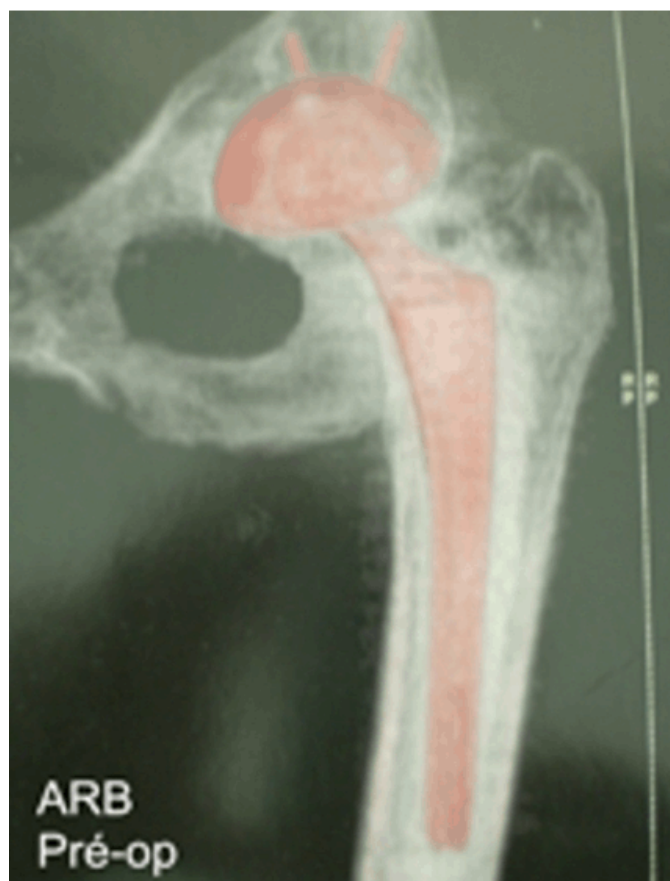
Figure 1: 3D-CT reconstruction image before use of US, without signs of loosening.

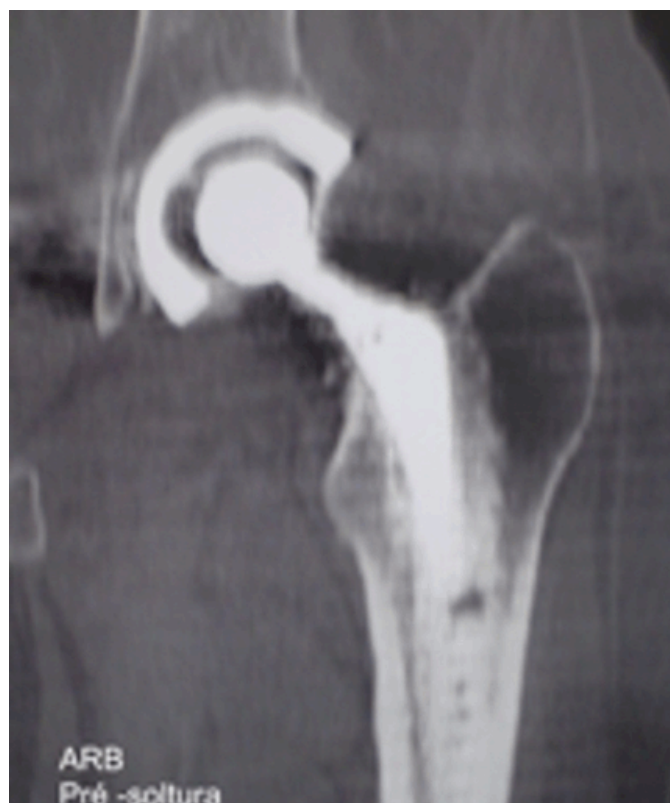
Figure 2: Coronal reformatted MPR CT image before use of US, without signs of loosening.

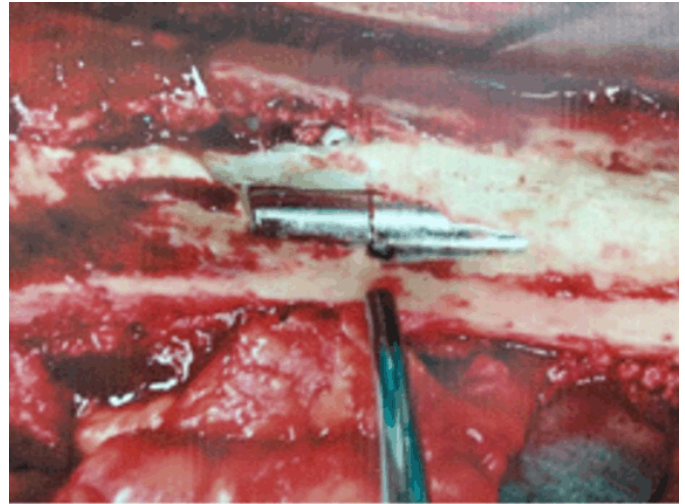
Figure 5: Intraoperative image of the revision surgery showing the broken stem.

in the characteristic of the pain that became progressively more severe and continuous in the thigh, exacerbated by walking. Radiographically, there was a clear stem-cement detachment in the femoral Gruen Zone 1 [13], without affecting the distal fixation (Figure 3), and fatigue fracture of the implant material in the region immediately distal to the detachment (Figure 4A and 4B). The treatment instituted was revision of the femoral component through extended femoral osteotomy (Figure 5 and 6) and replacement by a non-cemented distally-fixed modular stem (Figure 7). At 42 months post-revision, he was asymptomatic and had an HHS of 92 (see timeline below).

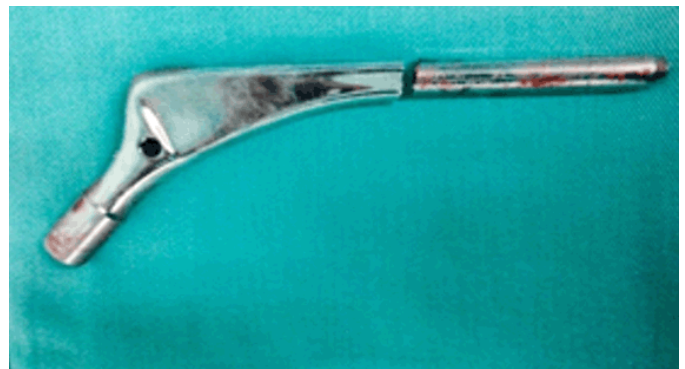
Figure 6: Detail of the fractured implant.

and no predisposing factors to fracture were identified. Local therapy with continuous ultrasound prior to the occurrence of the implant fracture was therefore considered a unique, isolated factor and the cause of the complication.

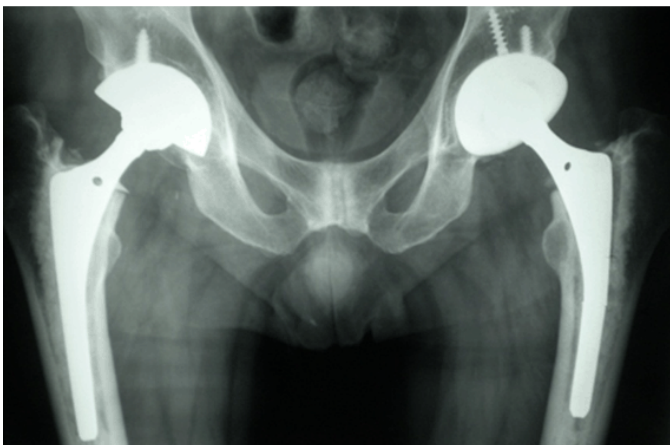
Figure 3: Bilateral hip X-ray with fracture of left side stem.

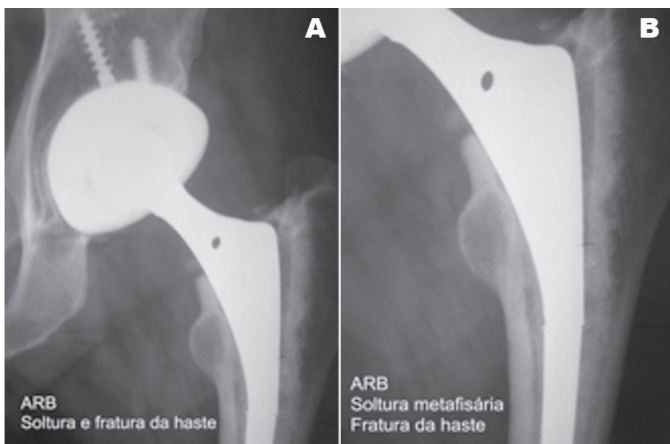
Figure 4(A and B): X-ray image with details of metaphyseal loosening and stem fracture.

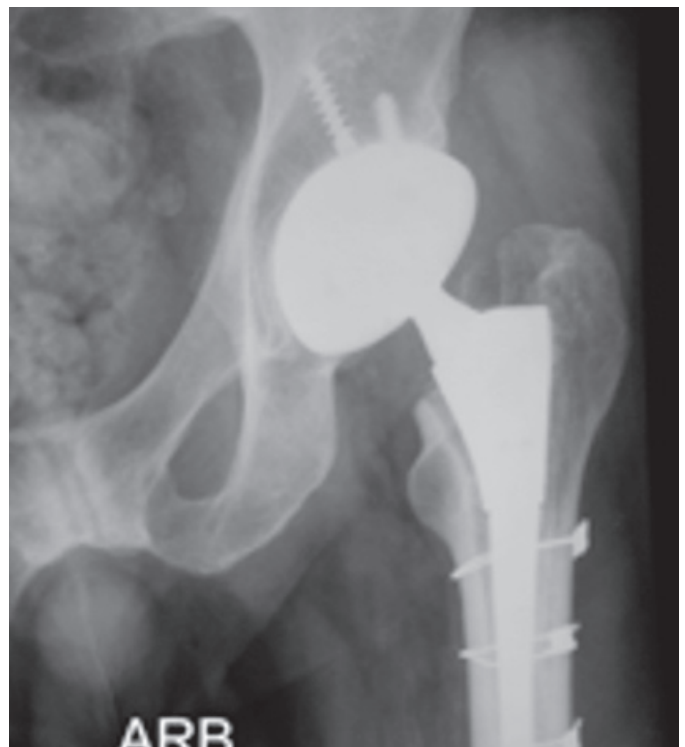
Figure 7: Post-revision X-ray appearance.
